## The Effect of Parameter Laser Markin and Immersion Time on Laser Marking Quality and Corrosion Rate of Stainless Steel S304LL Grade 2B in Seawater

Corrosion is the term for damage to metallic materials brought on by the metal's contact with its surroundings. This procedure uses high-power laser radiation to create permanent markings while also altering the material's surface structure. But a material's vulnerability to corrosion can also be impacted by laser marking, especially when 304L stainless steel is exposed to saltwater. This study aims to identify the laser marking parameters, the impact of immersion time on laser marking quality, and the rate of corrosion of 304L stainless steel in saltwater. This study employed a 90-day immersion period. A laser marking method was used to mark the surface of 304L stainless steel. Quality testing was made possible by analyzing the material's weight loss following the laser branding procedure. A laser marking method was used to mark the surface of 304L stainless steel. The quality of the laser marking was evaluated by measuring the weight loss of the material following the immersion procedure. The degree of corrosion on the material's s

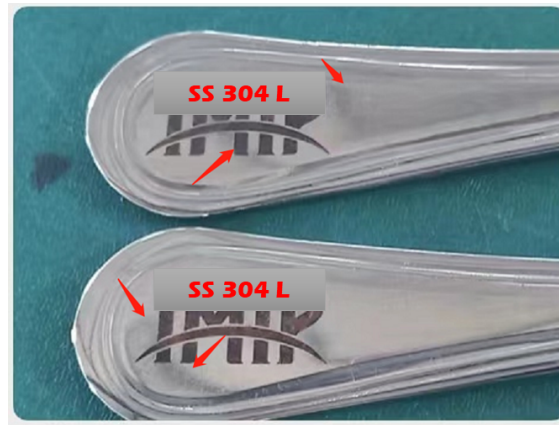
**Figure 1.** Sample Stainless Steel 304L Before Corrosion

In this study, Stainless Steel will be cut into a square shape, after which the surface of the specimen will be cleaned by polishing. Then, the specimen will be laser marked using the MAX M5 Box 20W laser marking tool with parameters speed 400, frequency 20, power 60, space 0.05. As shown in the image 2.1 below It is known that the higher the power, frequency, and speed of the laser, the greater the damage received on the surface of the material. The surface damage of the material can be seen in the SEM test in Figure 3.

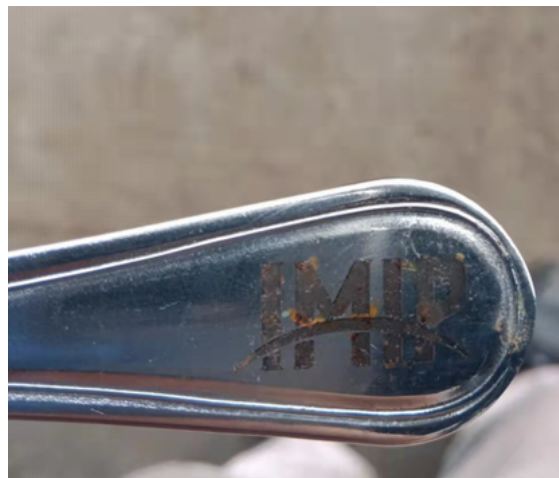
**Figure 2.** Sample Stainless Steel 304L After Corrosion
