The Analysis of Sheet Pile Assets Management in Musi River

Abstract

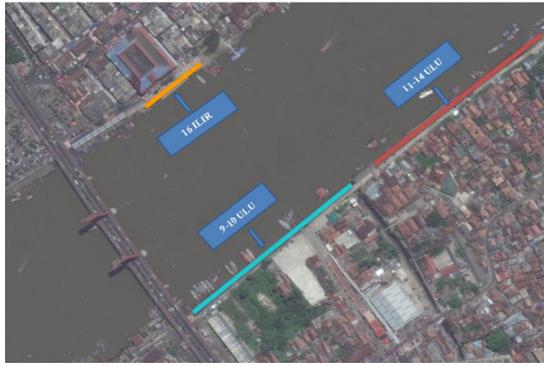
Figure 1. Study area

The study area were located in Ilir section, sheet pile in front of 16 Ilir Market, and in Ulu section, sheet piles in 9-10 Ulu and 11-14 Ulu which were located in the center of Palembang, South Sumatera. In this case, the construction of sheet pile in Musi River in Palembang was functioned as cliff reinforcement which was one of the ways to overcome the riverbank scour. These sites were chosen by considering the years of building the sheet piles. Here are the different research sites of Musi sheet pile that can be seen in Figure 1.
